# **LINEX** Sheave Liners

LINEX™ liners are designed and manufactured to equip and protect sheaves of chairlifts, gondolas, cable cars, funiculars, 3S, and other ropeways

## TECHNICAL INFORMATION

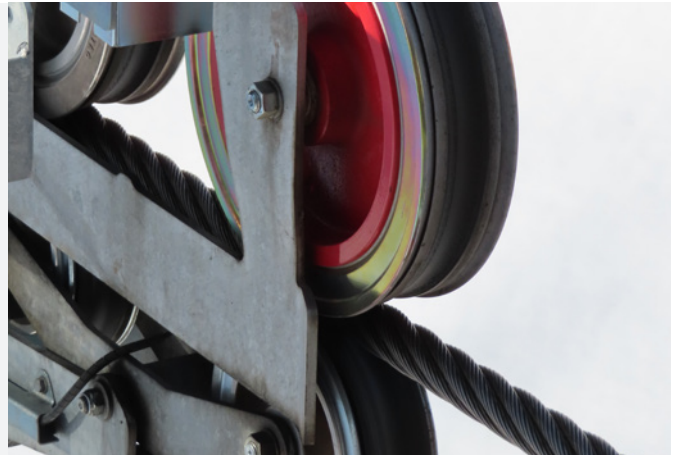
### OPTIMAL MOUNTING INSTRUCTIONS

Clean liner and sheave ring (oil and greasy deposit have to be removed).

Use specific equipment like a metal cone with de-burred edges.

Press the liner on wheel's hub. You can use soap water to lubricate the liner in order to facilitate the mounting (don't use too much).

- Don't use oil or grease to lubricate the liner
- Don't overstretch the liner
- Don't pull the liner over sharp edges

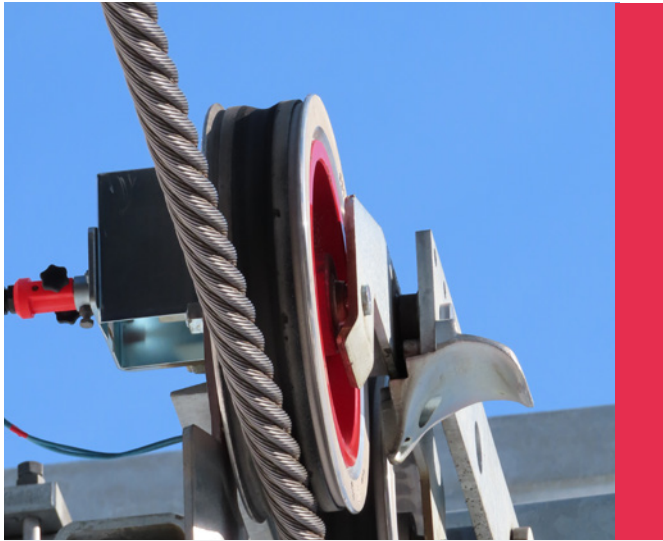
**LINEX™** liners are designed and manufactured to equip and protect sheaves of chairlifts, gondolas, cable cars, funiculars, 3S, etc...

**LINEX™** liners are not molded and are closed ring only (we do not manufacture open ring liners yet).

Our high-quality manufacturing process allows for the production of any ring dimension and groove shape. We can even make a customized ring with a customize groove if needed.

**LINEX™** liners are manufactured with a perfectly uniform material structure due to the extreme precision we use with regards to rubber in our manufacturing process.
